Refurb for a swing keel

Clonking noises signalled time for a look at the cast iron underbelly and pivoting centreboard of **Mike and Margaret Blatcher's Kelt 8.50m**

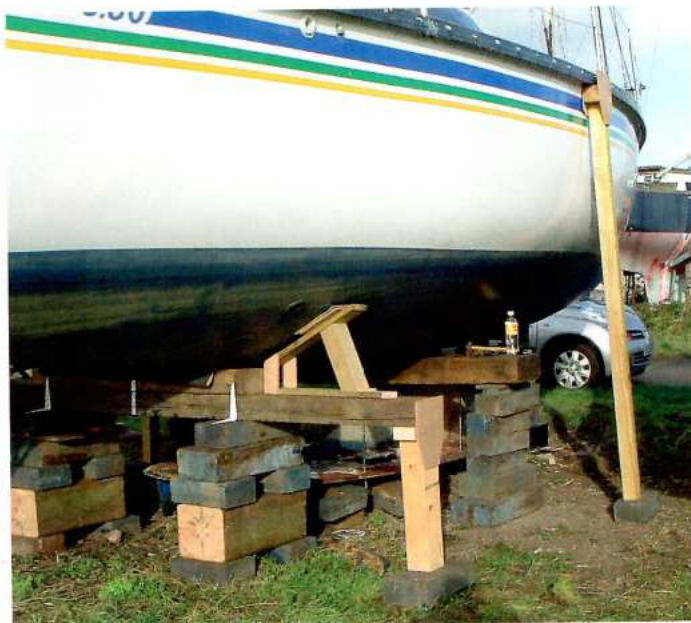
Hull was made steady with substantial wooden blocks, wedges and legs

Measurements were taken to find how high the boat would need to be off the ground to allow for clearance in case the centreboard had to be taken out from under the boat for repair. A substantial wooden base was made for a forward tower of wooden blocks, while two other towers supporting a crossbeam were built near the stern. Wedges were made and secured to the beam to stabilise the hull, and legs were fitted to prevent any movement in strong wind. The legs were bolted

through the toe rail to make them extra secure.

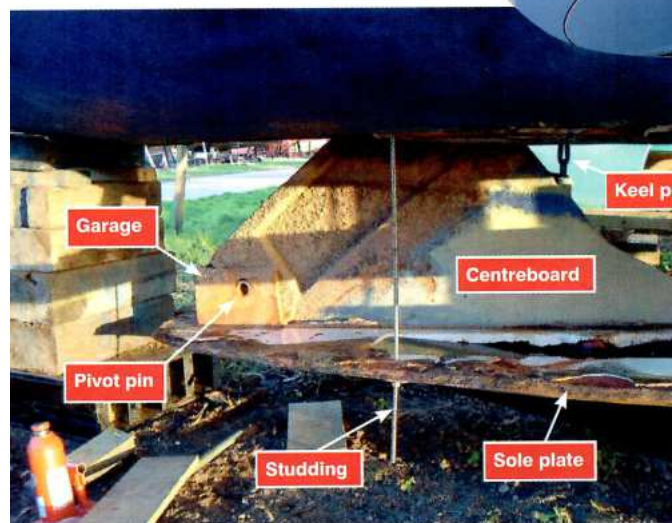
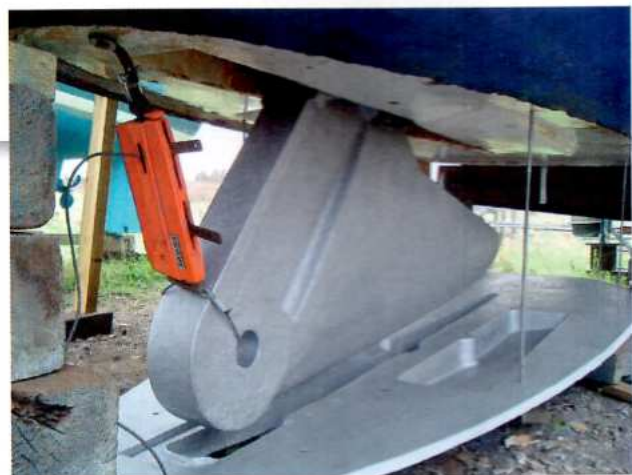
Anatomy of the centreboard keel Kelt 8.50m

The lifting mechanism of the pivoting centreboard of 370kg (800lb) is taken through to the cockpit where a multiple purchase system reduces the effort necessary to raise and lower the keel. The stiffness of the central skeg and two smaller skegs make the Kelt 8.50m an extremely stable centreboard boat'

The forward bolt hole in the hull was utilised as an attachment point for a small jockey winch to help manoeuvre the heavy centreboard

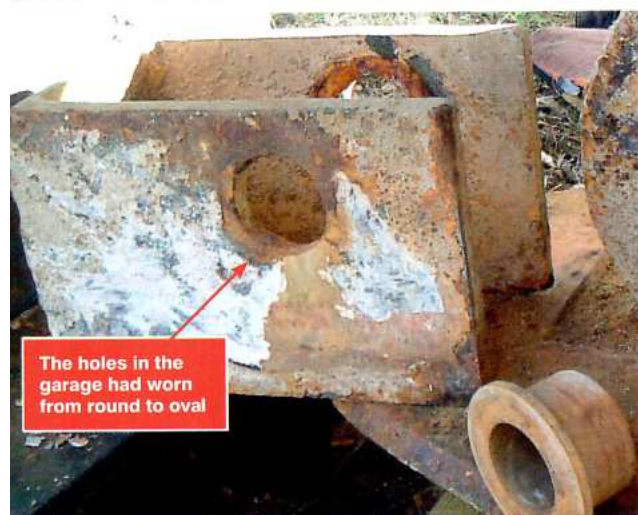
The holes in the garage had worn from round to oval

holes in the garage had worn round to oval, although the pivot pin, nylon bearings and hole in the centreboard showed no signs of wear. Importantly the galvanised sole plate could be easily removed, leaving the centreboard, studding and pivot pin in place for realignment later.

The repair to the garage involved machining out the hole for the pivot pin to make it round, and then bushing the hole with stainless steel. To prevent any subsequent movement of the bush the top of the garage was drilled and the bush secured with a countersunk stainless steel screw. The garage was cleaned up and then painted with Primocon.

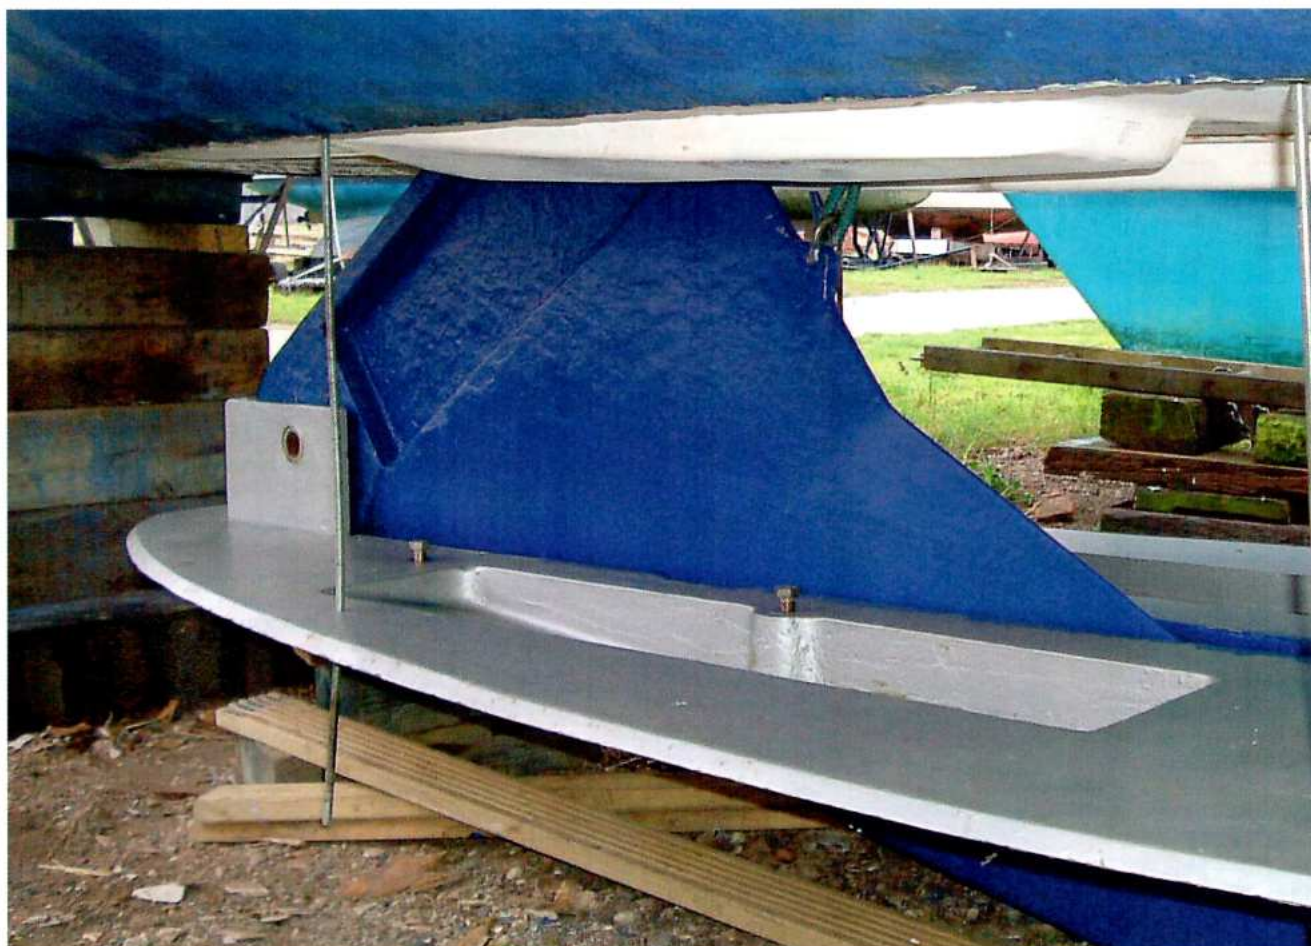
Cleaned, refurbished and re-painted, the reassembled centreboard and sole plate are ready to be hoisted back in position, guided by the threads

The garage was held in place with epoxy filler while a polysulphide sealant was spread evenly all over the grounding plate. The time had come for a speedy ascent. Three jacks were used to lift the sole plate and as it ascended the nuts were spun up the studding. If the plate became out of line the jacks were eased off

and the plate swung on the studding to realign itself. Eventually the sole plate was close enough to the hull to wind the securing bolts back in. One by one the bolts were tightened as excess polysulphide was squeezed out from round the edge.
